**Notice of Availability  
and Request for Comments**

**Proposed Draft Restoration Plan  
and Environmental Assessment  
for the Col-Tex State Superfund Site**

**FINAL DRAFT**  
**Habitat Enhancement and Restoration Plan**  
**Compensatory Restoration**  
**Col-Tex Site**  
**Colorado City, Texas**

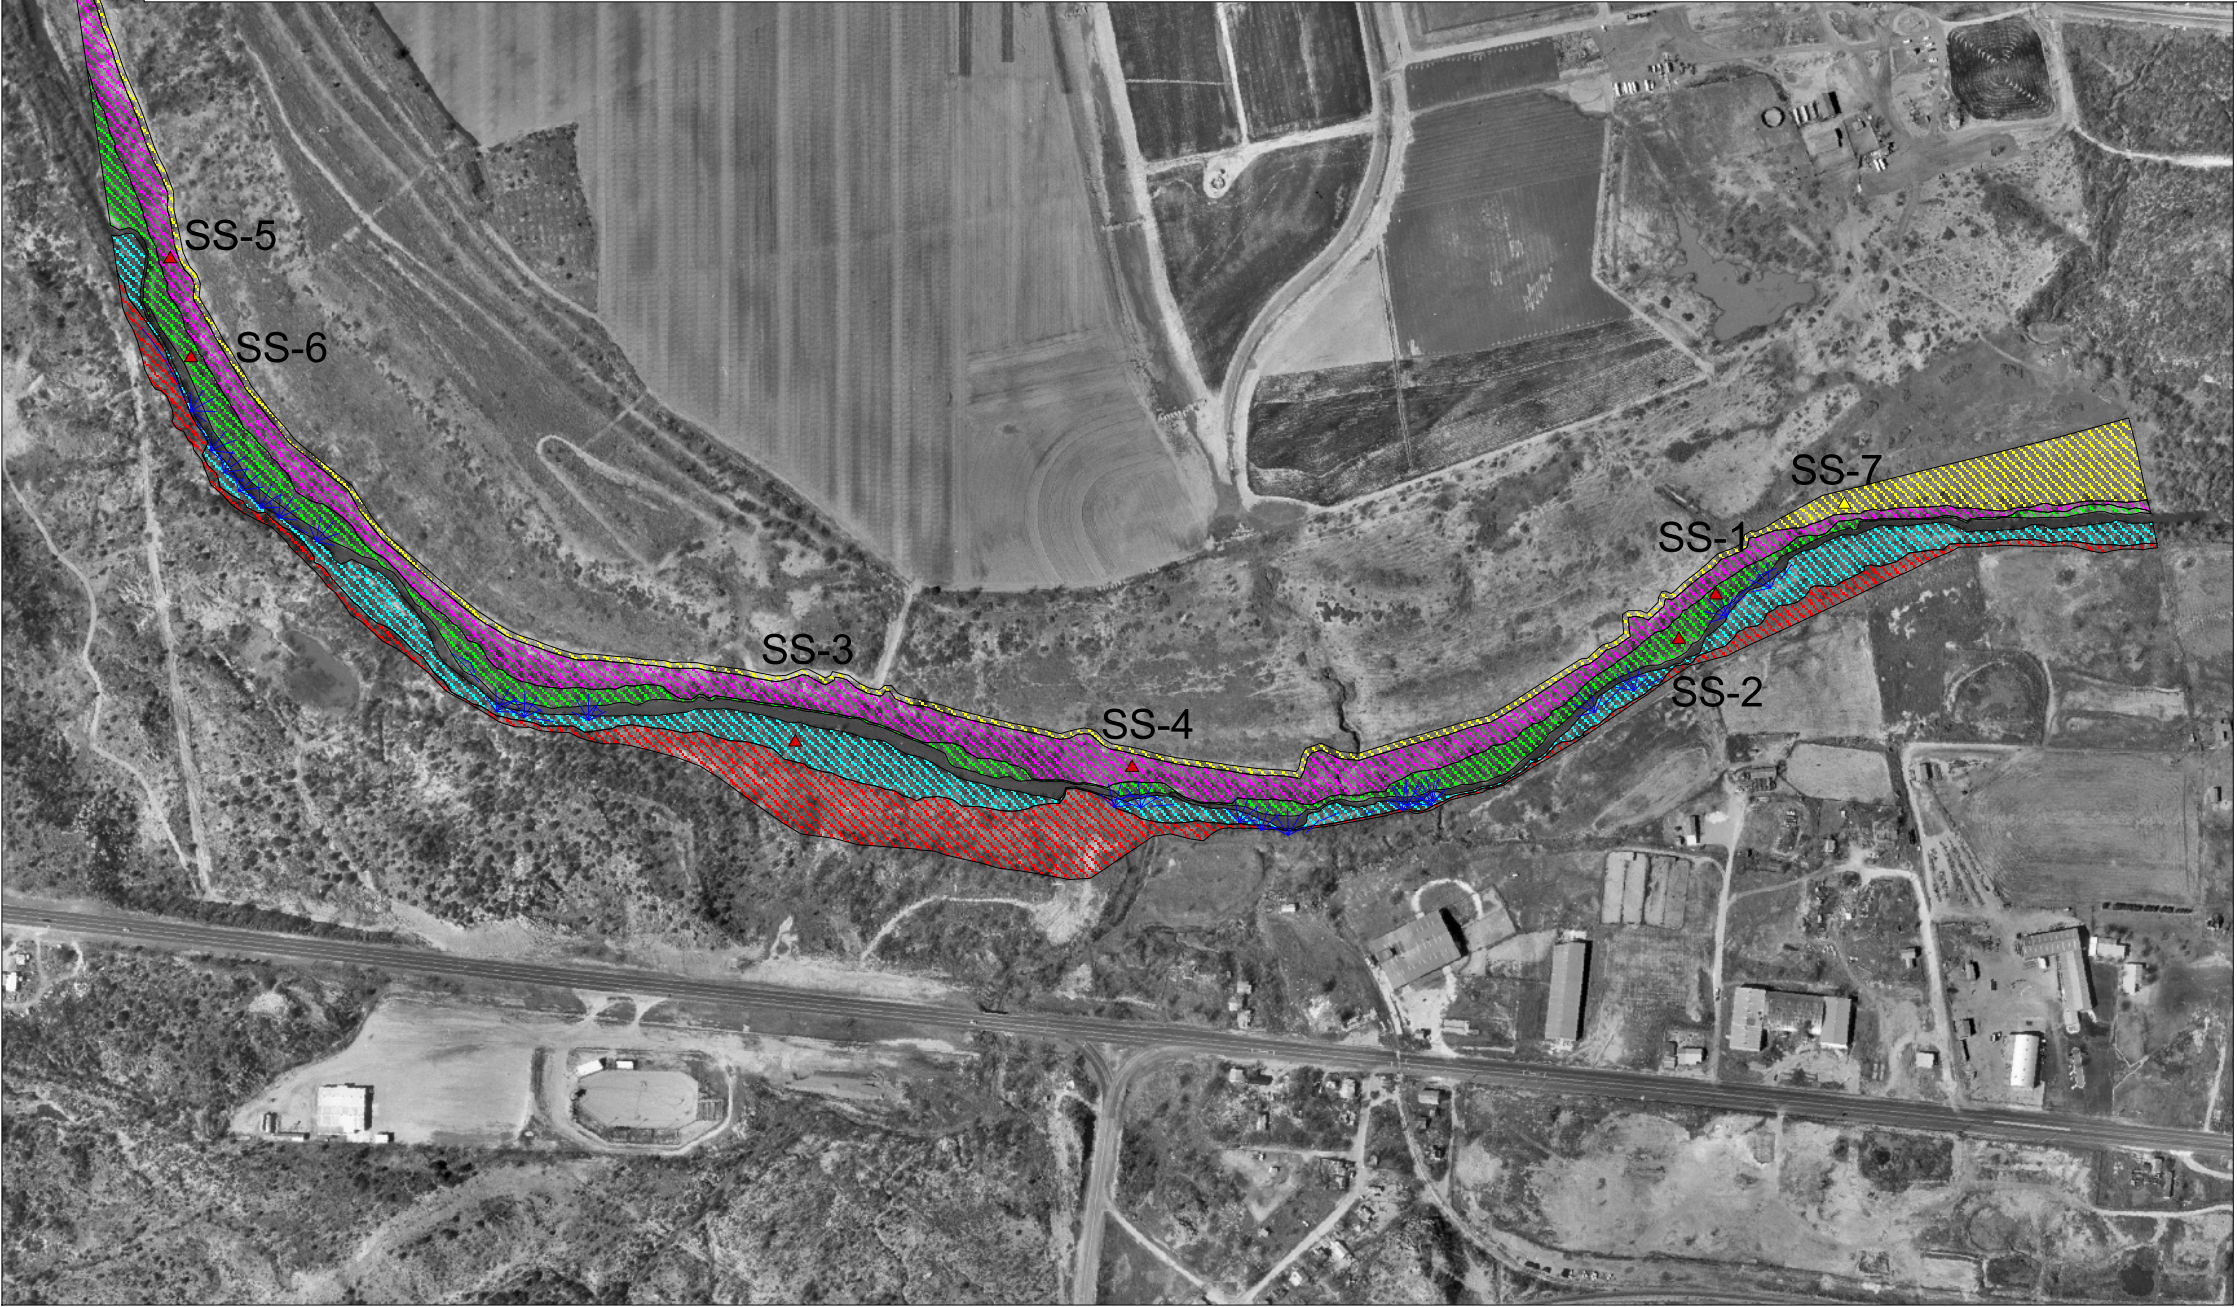
Figure 6.2.1  
Riparian Area  
Existing Conditions  
Col-Tex Restoration  
Colorado City, Texas

The following is a description of each sampling site, as shown on Figure 6.2.1:

4 - North: Dominated by Mesquite. Herbaceous layer includes: Johnson Grass, Switchgrass, and Tumbleweed

within the river's flood-prone area. Within the river and on adjacent banks, wetlands comprised of sedge and cattails are also present. Figure 6.2.1 shows the areas that have been stripped of vegetation, current distribution of plant species along the subject reach, location of existing wetlands, and the areas of dense salt cedar. The invasion of the riparian system with salt cedar, as well as the vegetation management practices along the subject reach of the Colorado River, has resulted in a riparian system lacking adequate vegetation, sources of large woody debris, and the diversity of plant species usual in unmodified riparian corridors.

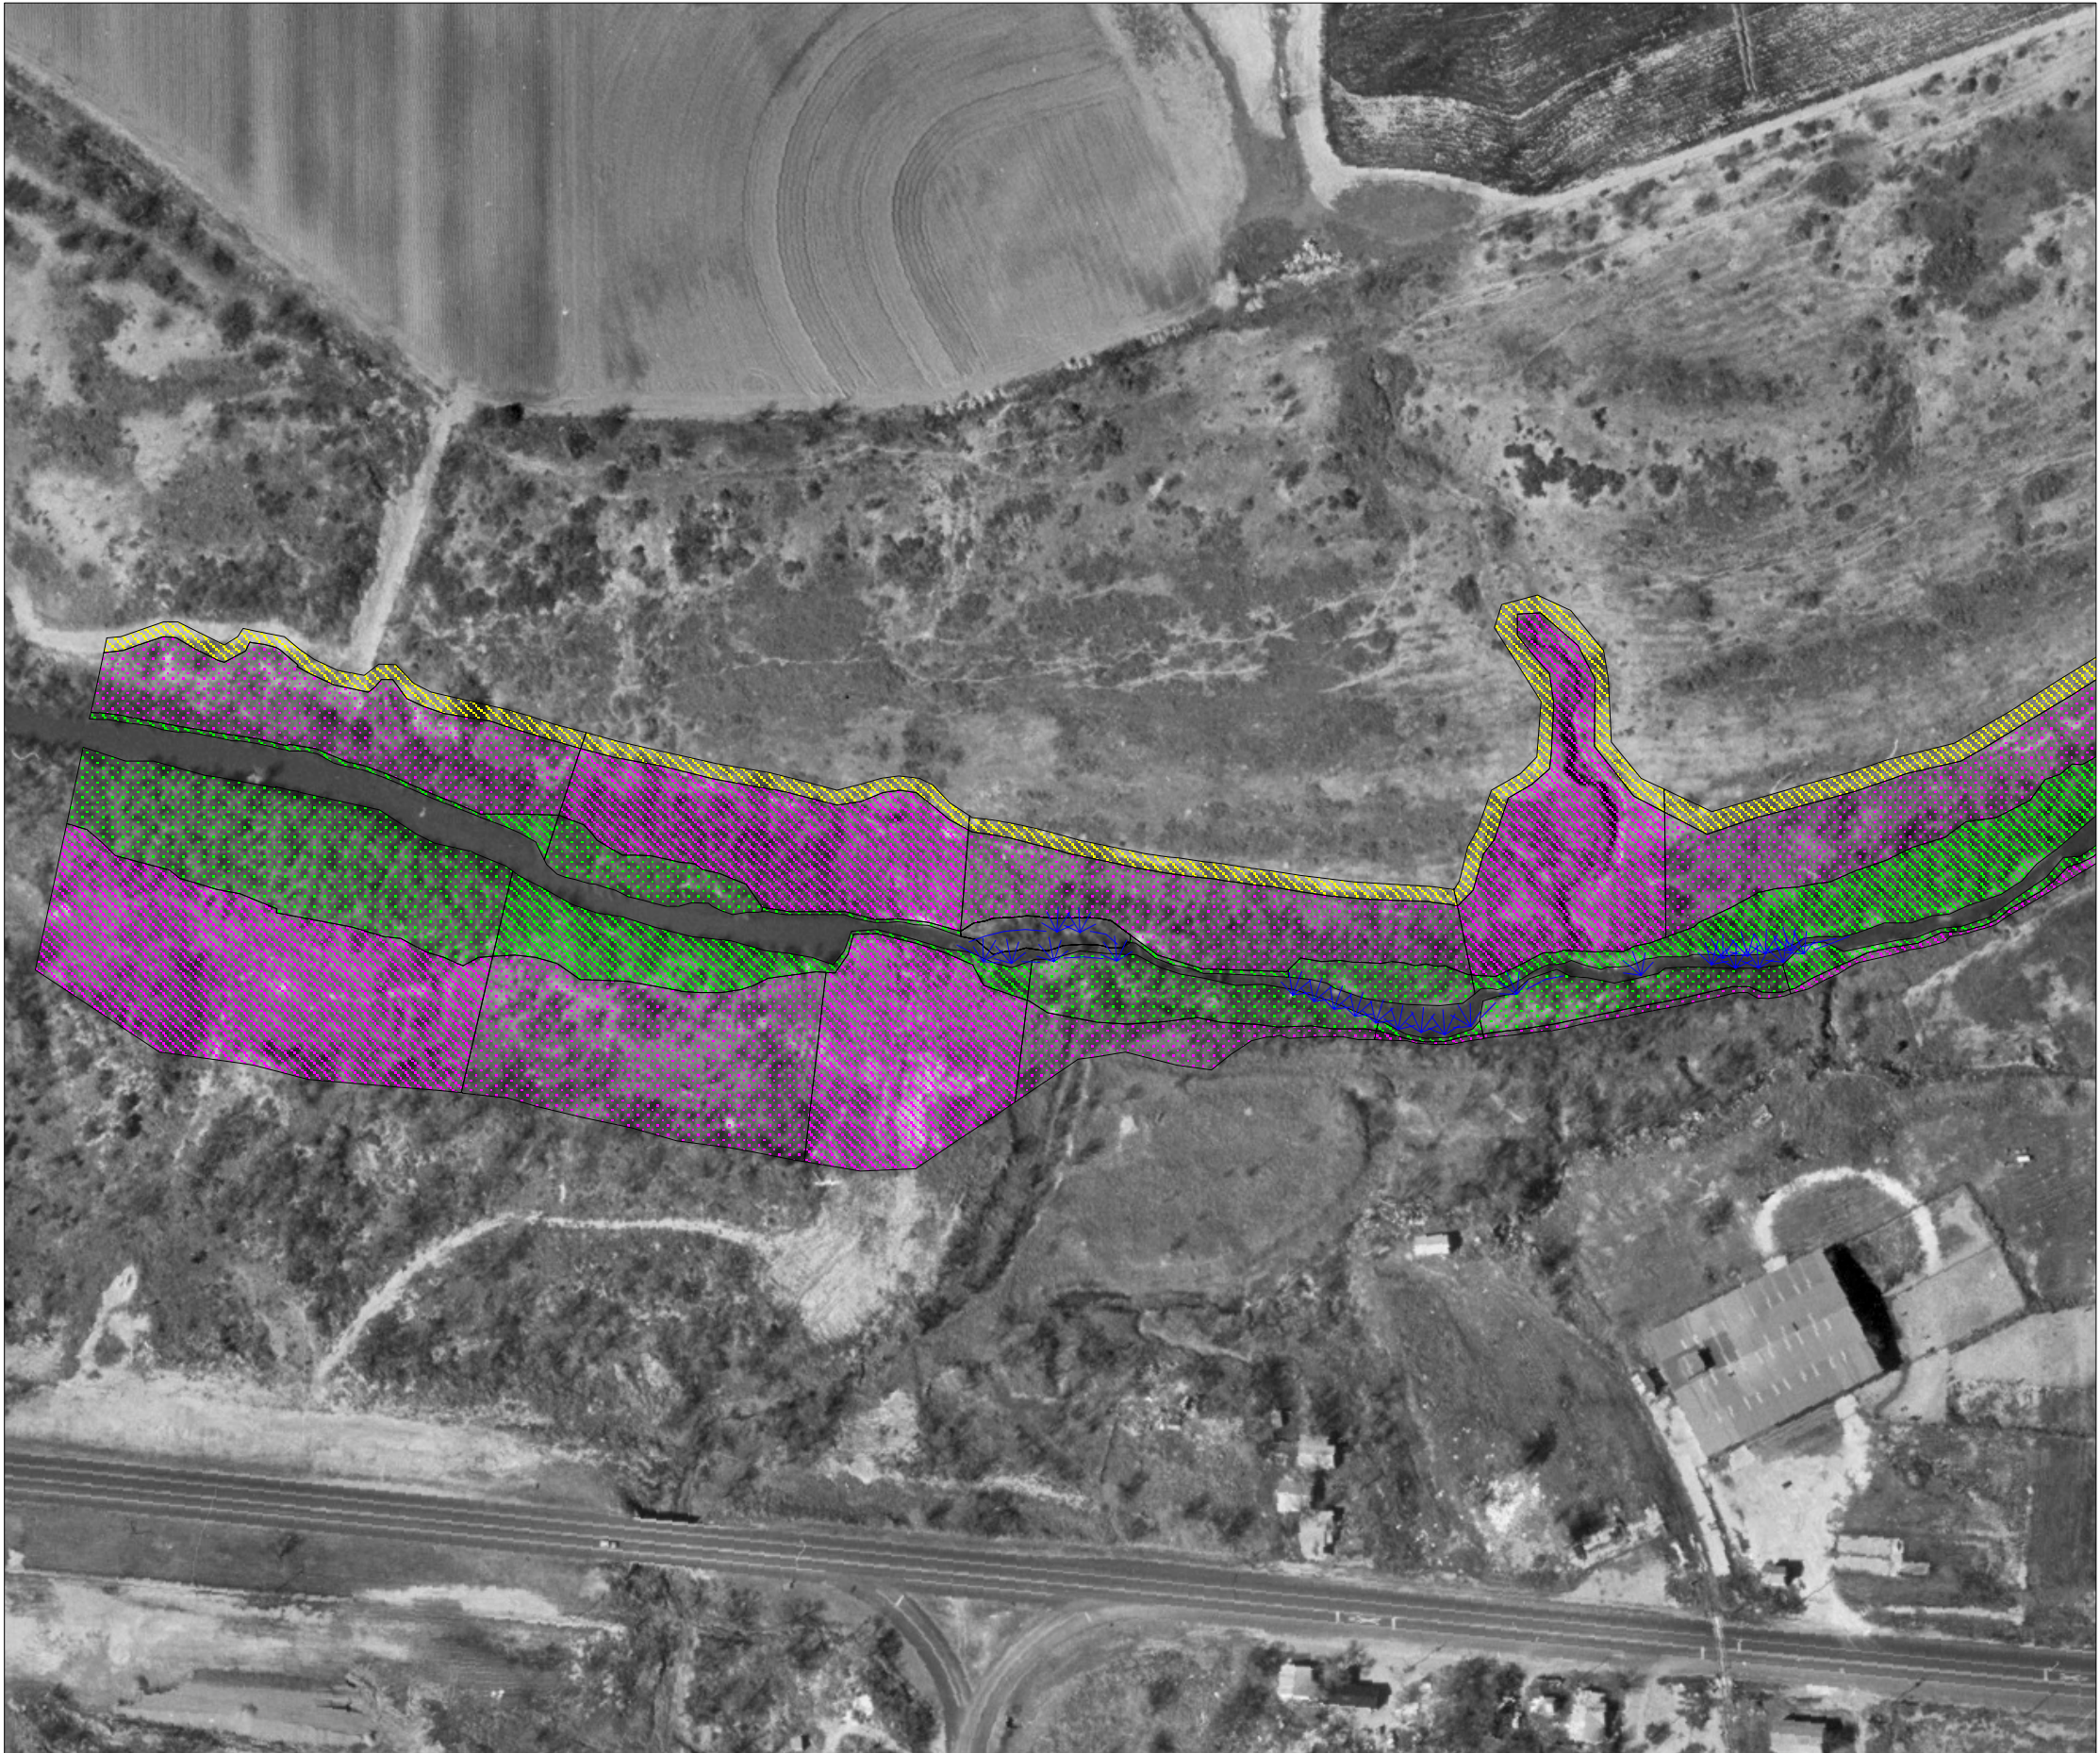
Figure 6.2.2 a

Riparian Planting Areas  
West Side  
Col-Tex Restoration  
Colorado City, Texas

Planting densities will vary along the reach. Dense clusters of riparian vegetation will be planted on either bank, separated by more sparsely vegetated areas and existing wetland areas. This mosaic will provide variability in the lateral pattern along the river. Figures 6.2.2a and 6.2.2b illustrate the mosaic that will be created by mixing sparse vegetation, dense vegetation, and existing wetland vegetation community areas. The pattern depicted on the figures provides a concept of the variability in planting densities. The goal of the planting plan will be to create a denser vegetative cover along the river channel, with cover becoming generally less dense moving uphill. Specific locations for the areas of denser vegetation will be determined based on topographic constraints, channel morphology, and outcrop locations. In addition, tree and shrub species will be planted within

See Figures 6.2.2a and 6.2.2b for delineation of zones and management units.

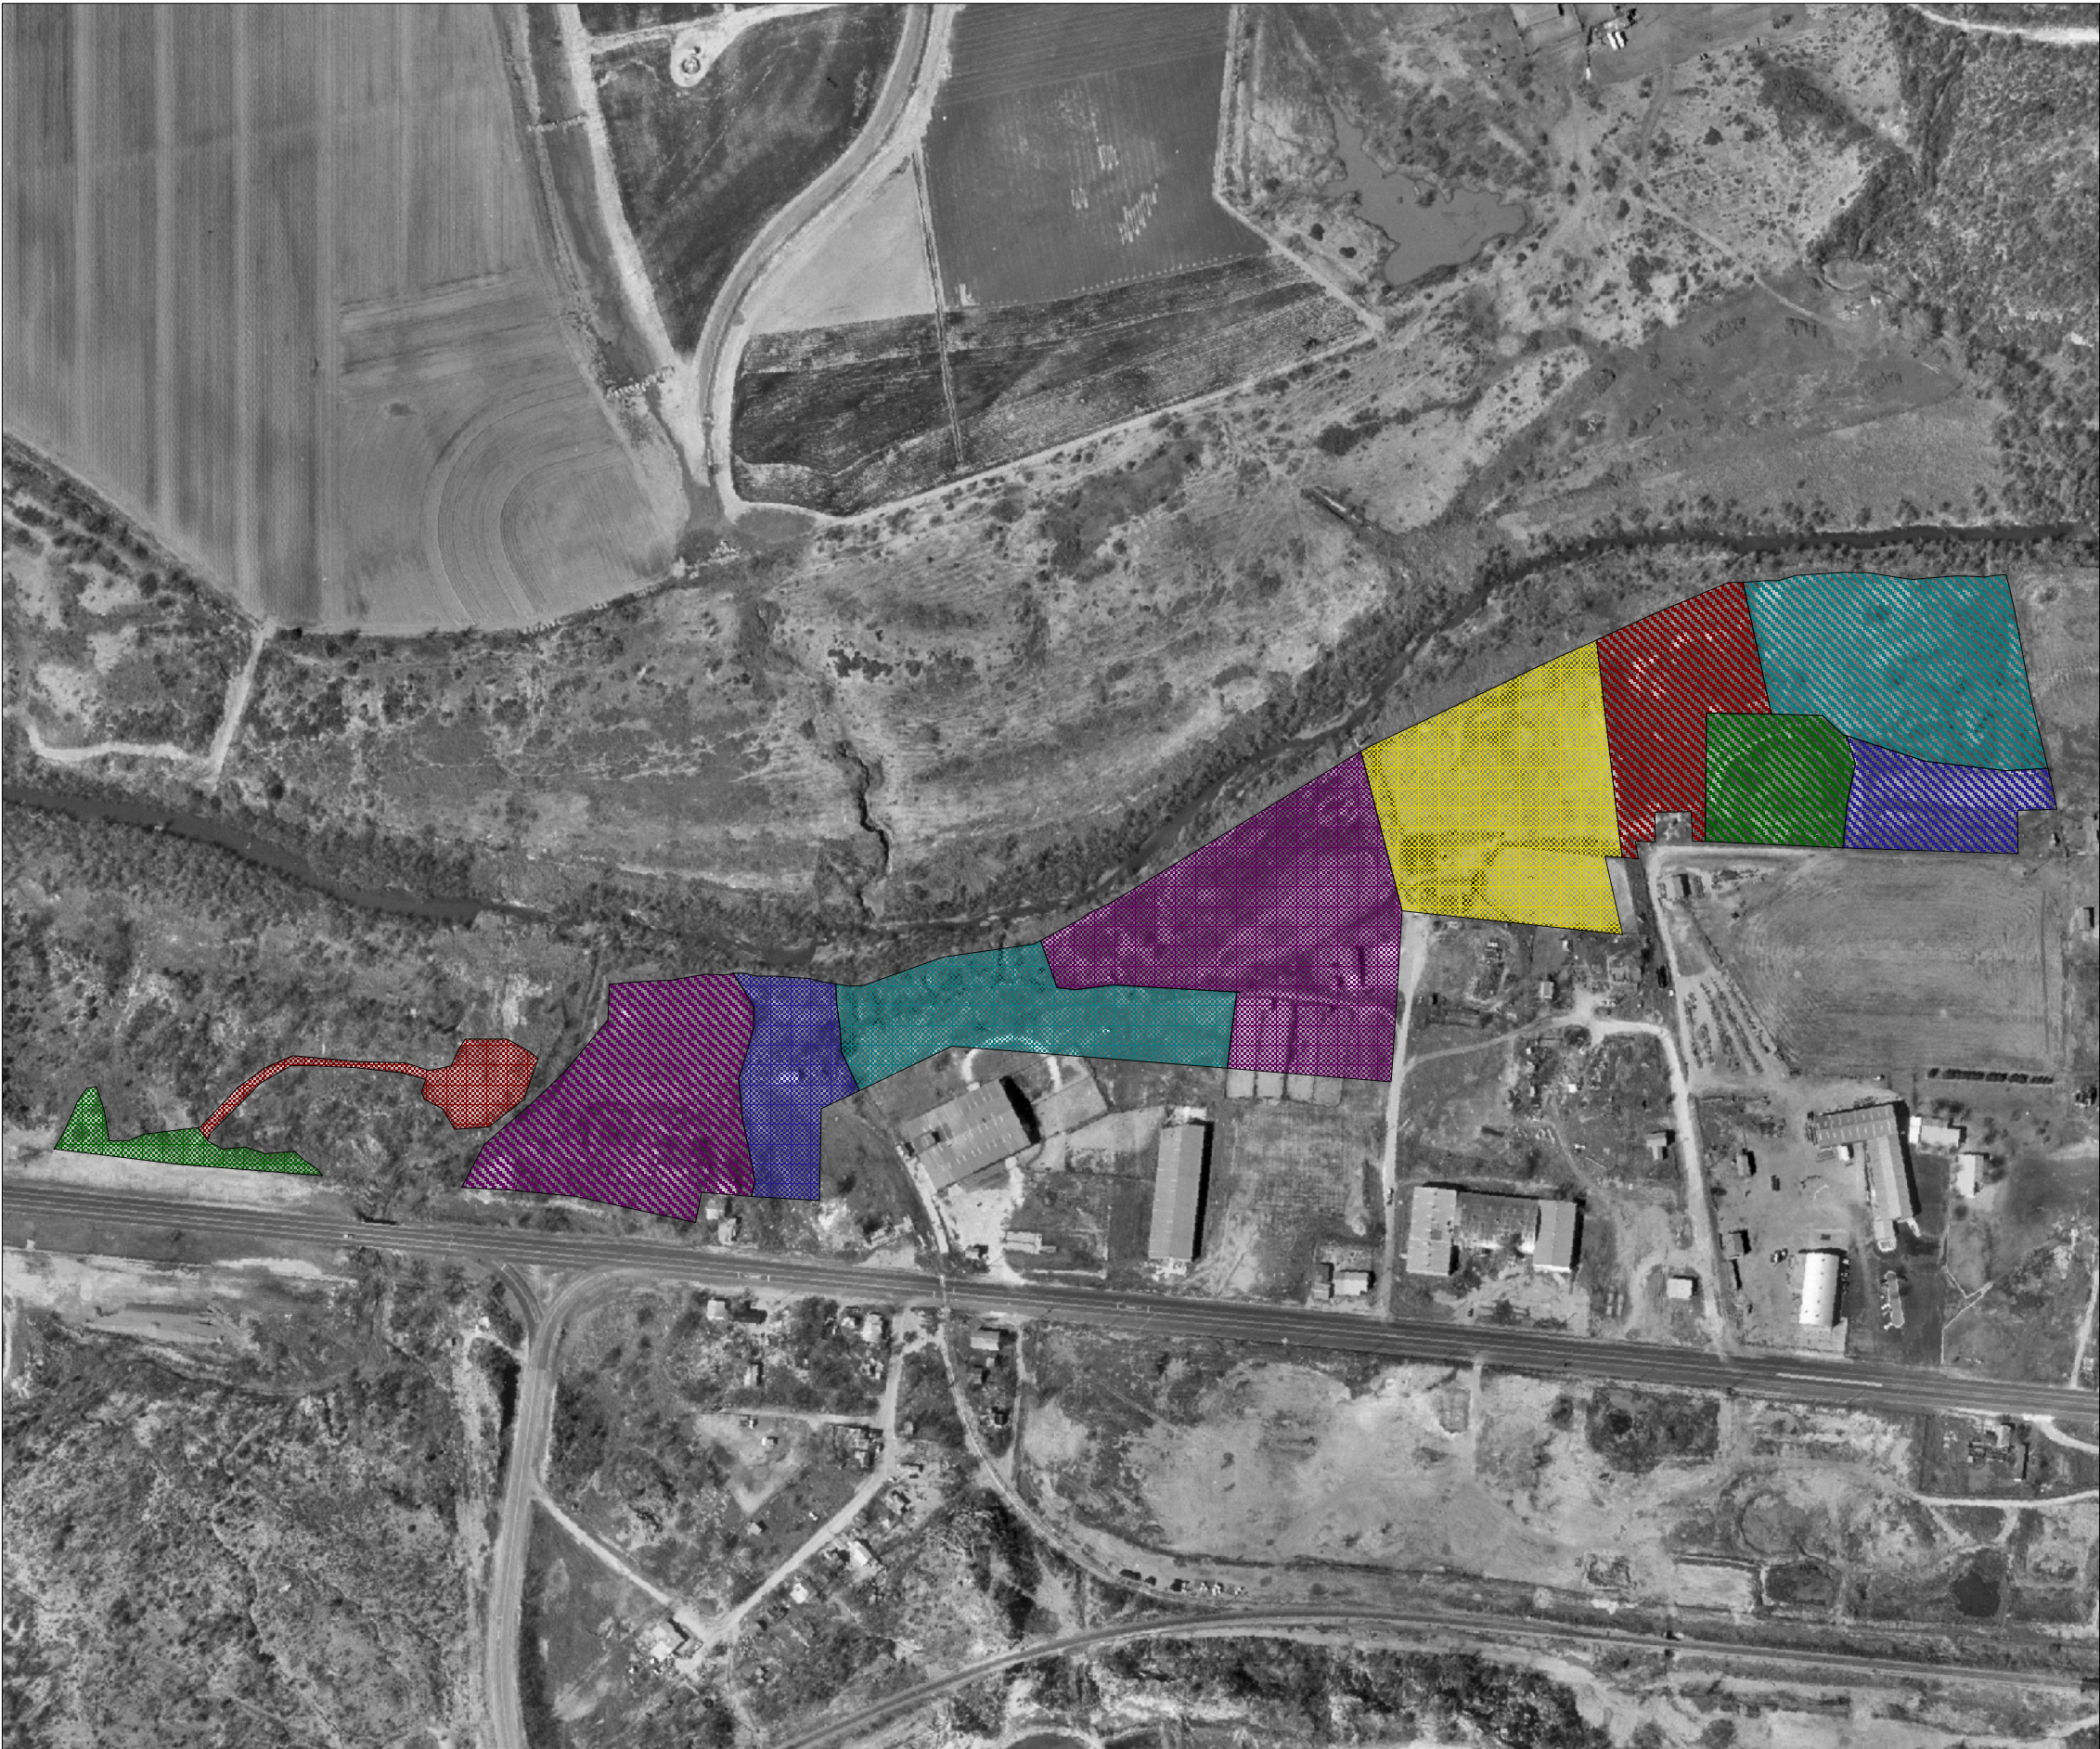
**Figure 6.3.2**

The following is a description of each sampling site, as shown on Figure 6.3.2:

The pH values for the upland site ranged from 7.3 to 8.0 which is typical for soils developed from coarse textured alluvial deposits. Fizz testing with 5% HCl acid suggested the slight presence of carbonates in the soil. No visual indicators of calcareous soils were evident.

The saline/sodic content of the upland site is best estimated with the analytical tests for electrical conductivity (“EC”) and sodium adsorption ratio (“SAR”). Only upland Sites B, H, and I exhibited slightly elevated soluble sodium values, which directly affected the EC and SAR values. Elevated sodium levels encountered at Sites H and I are at moderate levels and should not be a concern because of the coarser textured sandy loam soils. The elevated levels at Site I

Johnson grass is capable of creating monocultures in areas favorable to its growth. This grass species has spread into adjacent undisturbed areas from past agricultural plantings. In particular, a monoculture of Johnson grass grows in one large field on the northwest side of the upland restoration site area (Area K on Figure 6.3.2). This area represents a potentially valuable upland habitat that currently has little habitat value.
